OPERATING EXPERIENCE WITH THE
EBR-II ROTATING-PLUG FREEZE SEALS

Larry P. Cooper, Bernard C. Cerutti,
and Donald W. Cissel

EBR-II Project

December 1969

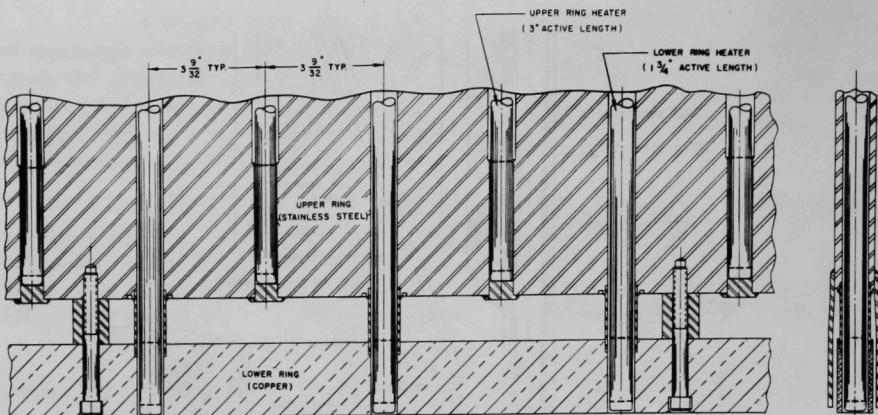
112-2865

A lower ring of copper, as shown in Fig. 6, was originally incorporated in the blade, but was later replaced by stainless steel for reasons discussed in Section II. The purpose of the copper ring (124.25-in. ID, 2.0 in. high, and 1.0 in. thick) was to minimize circumferential thermal gradients. There was a 1.25-in.-high inert-gas void for insulation between the lower, copper ring and the upper, stainless steel ring.

Fig. 6. Arrangement of Upper and Lower Blade Rings and Heaters

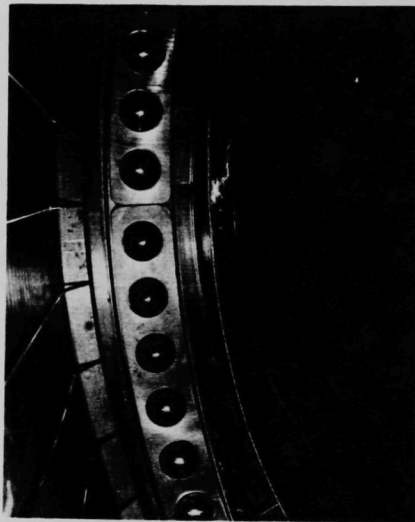
ID-103-A5575

Figure 11 shows the large-plug seal trough after removal of the plug. The "crud" at the trough bottom consisted of undrained tin-bismuth alloy and copper. Analysis indicated that this material contained up to 8% copper, but the sound alloy (samples from the alloy drained from both troughs) contained only a few hundred ppm of copper. For comparison, Fig. 12 shows the empty trough with insulator cans and retaining clips before installation of the plug.

Fig. 12. Large-rotating-plug Seal Trough
before Plug Installation

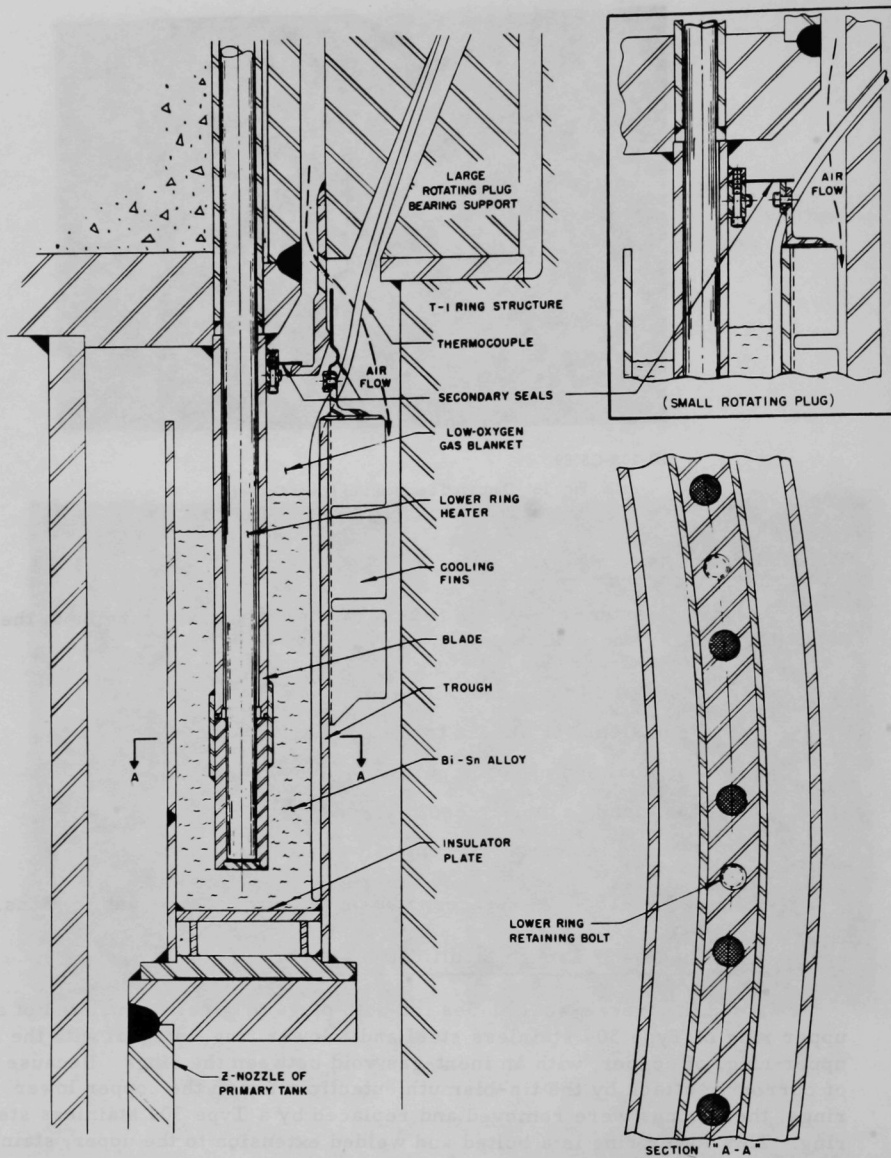
ID-103-5199

Fig. 14. Cross Section of Large- and Small-rotating-plug Freeze Seals after Modification

The freeze-seal blades for both plugs originally consisted of an upper ring of Type 304 stainless steel and a lower ring, integral with the upper ring, of copper, with an inert-gas void between the rings. Because of corrosive attack by the tin-bismuth eutectic alloy on the copper lower rings, these rings were removed and replaced by a Type 304 stainless steel ring. This lower ring is a bolted and welded extension to the upper, stainless steel ring and is 3.25 in. deep. To compensate for the lower thermal conductivity of the stainless steel lower ring, the active (heated) length of each of the upper electrical-resistance heaters was extended downward into the lower ring; the active length of the upper heaters was increased from 3.3 to 5.5 in., and the active length of the lower heaters was increased from 1.75 to 2.50 in. (see Fig. 17).

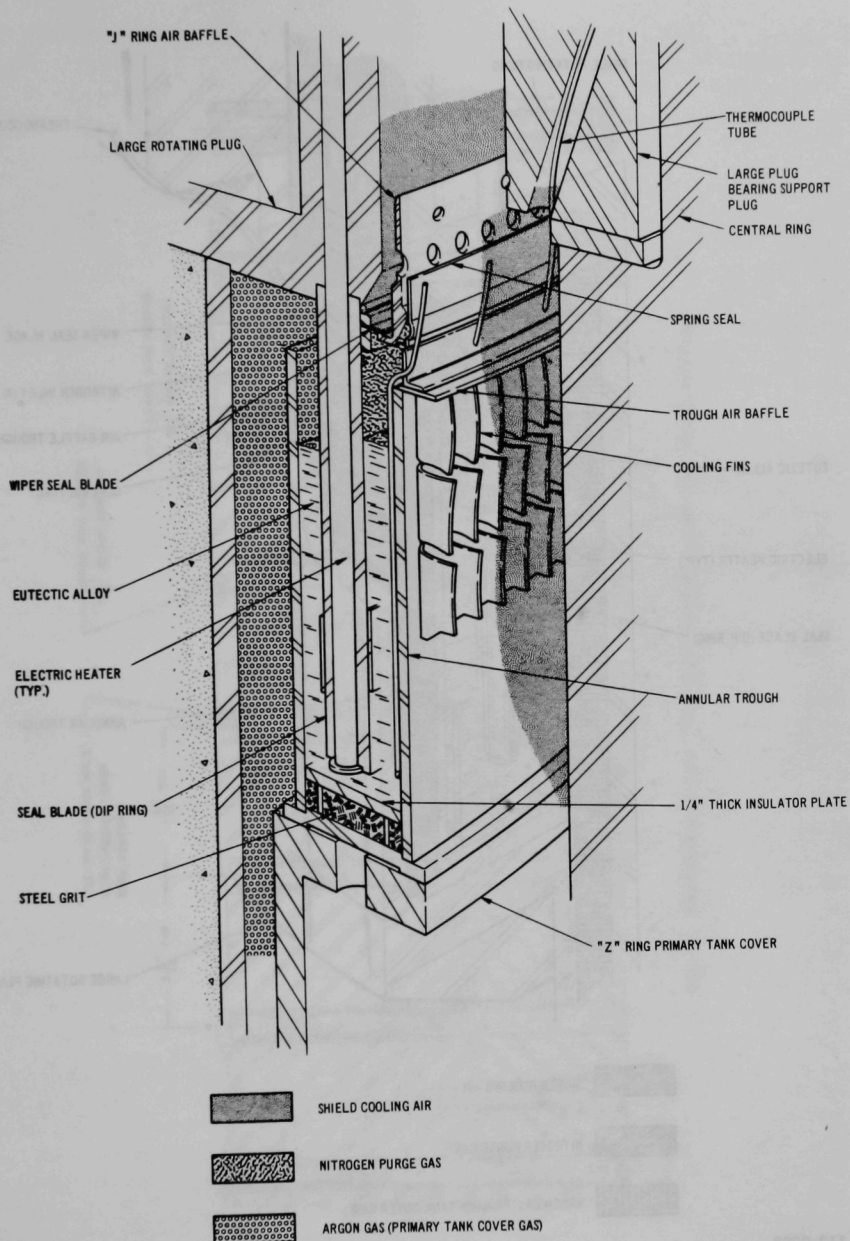
Fig. 15. Isometric View of Large-rotating-plug Freeze Seal after Modification

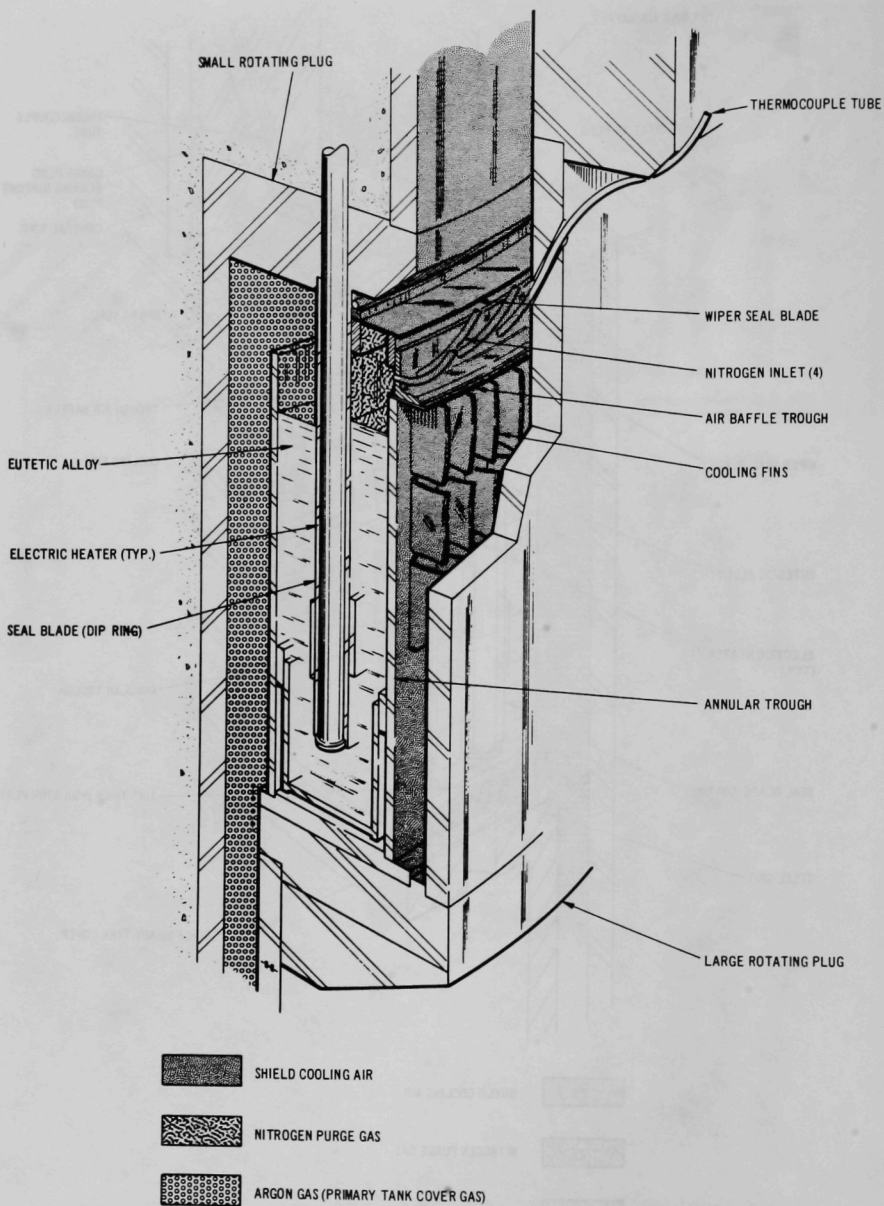
113-2728

Fig. 16. Isometric View of Small-rotating-plug Freeze Seal after Modification

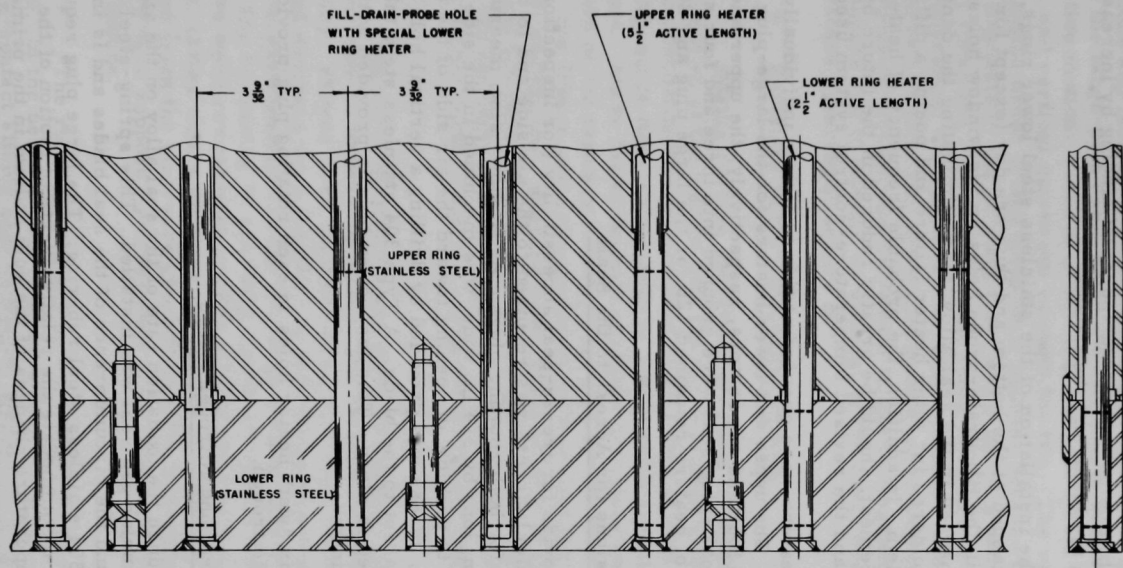
112-2838

Fig. 17. Arrangement of Upper and Lower Blade Rings and Heaters after Modification
